# **Stillwater Basin Evaluation Report**

**Former Robert E. Derecktor Shipyard/  
Coddington Cove**

**Naval Station - Newport  
Newport, Rhode Island**

**December 1998**

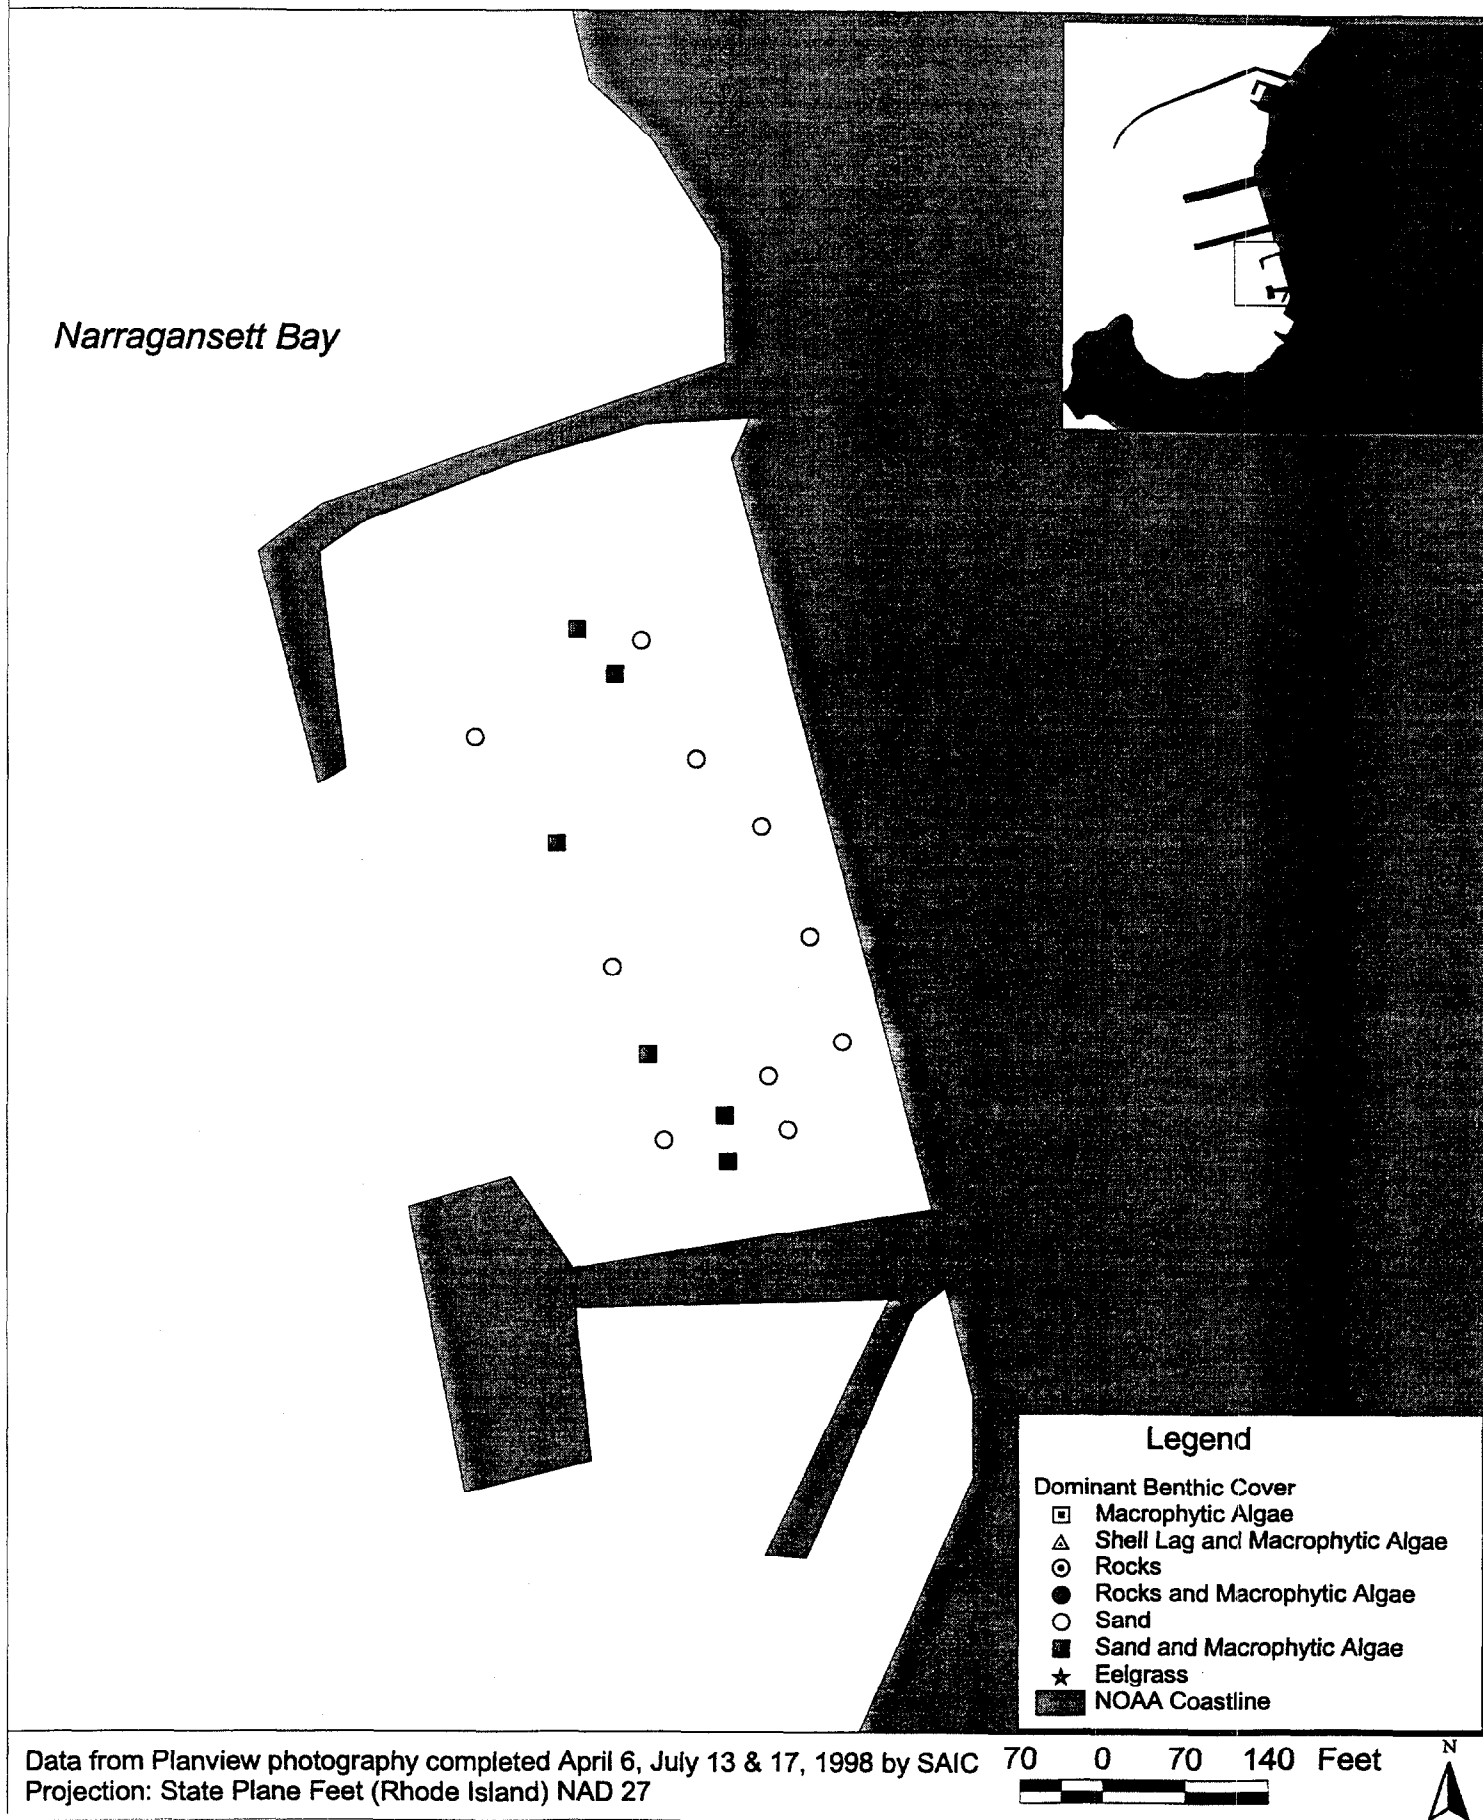
Figure 1.2-1b. Dominant benthic cover in the stillwater basin section of the Derecktor Shipyard/Coddington Cove study area.

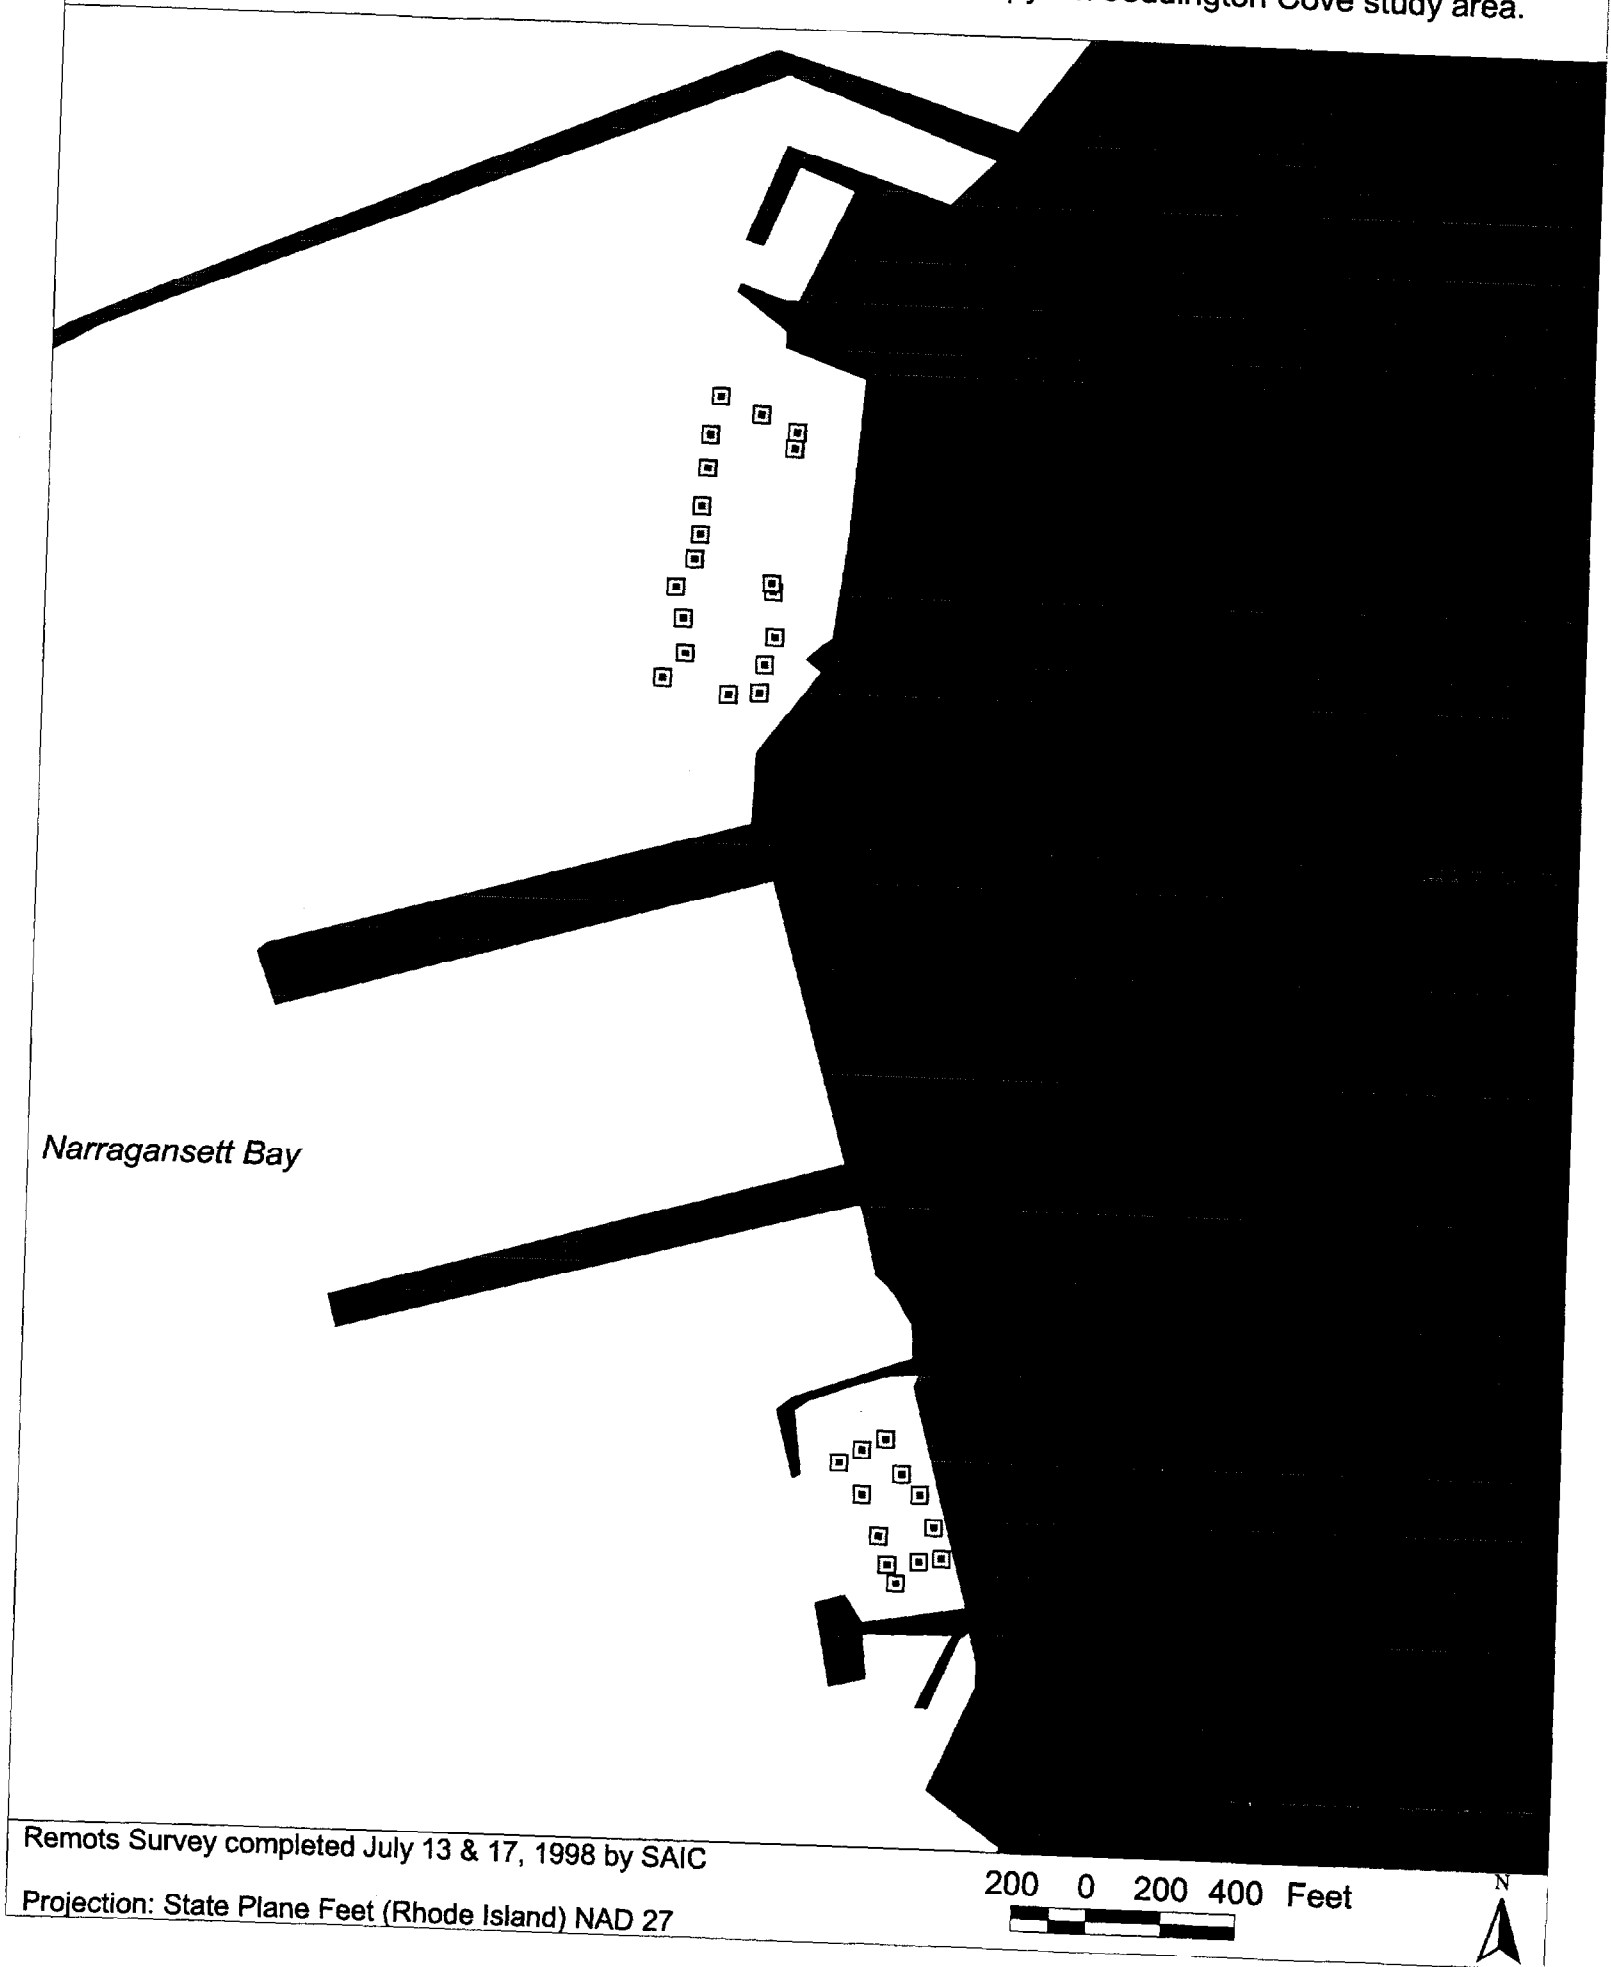
Figure 1.3-1. REMOTS survey stations off the Derecktor Shipyard/Coddington Cove study area.

*Survey Results.* Figure 1.3-1 shows the location of the REMOTS survey stations south of the YP Pier in northeastern Derecktor Shipyard/Coddington Cove. From this imagery, several representative classes of habitat were observed, including 1) deep camera prism penetration showing both the absence of infauna and apparent sediment

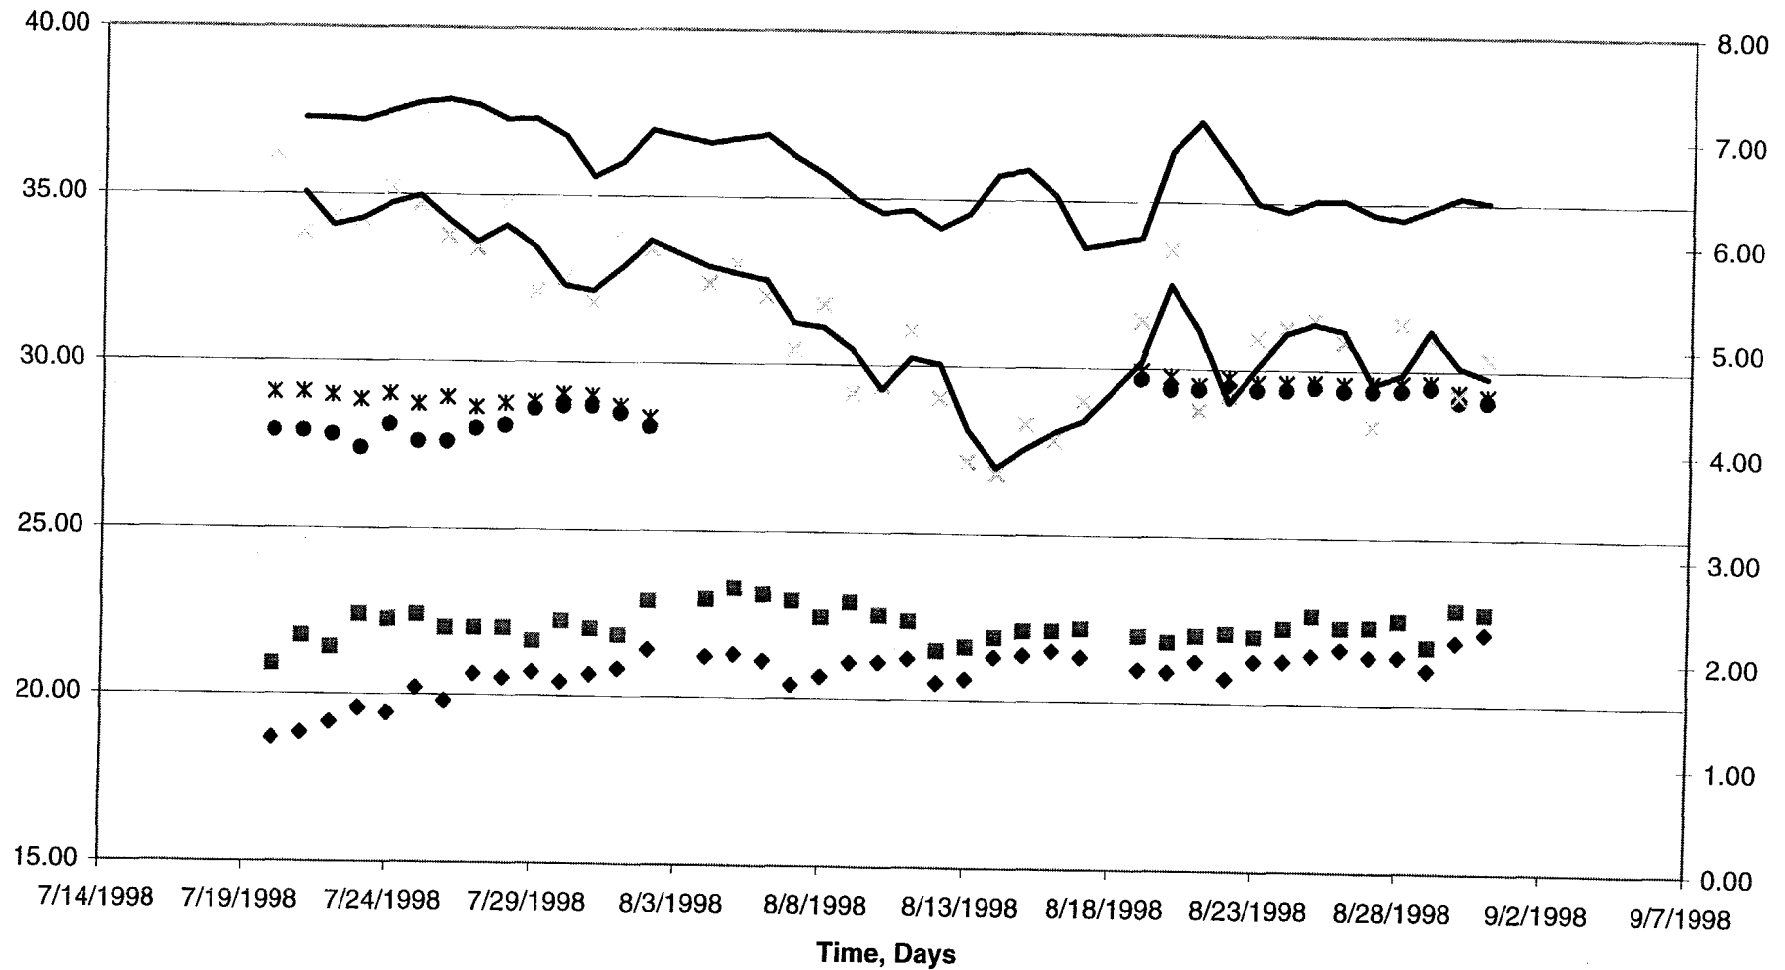
Figure 1. Time Series Water Quality Trends at Station DSY25/26

Reference area data for temperature indicates a general warming trend and more consistent temperatures (diminished variation between mean and maximum temperatures) as the deployment period progressed. A similar pattern was also observed for salinity. In apparent response to increasing temperature, dissolved oxygen concentration declined steadily through the deployment period reaching a minimum of 3.5 mg/L on 8/14/98. It is also notable that the average DO concentrations increased as minimum DO values dropped rapidly from 8/10/98 to 8/15/98. This phenomena is attributed to wide swings in diel oxygen concentration which can

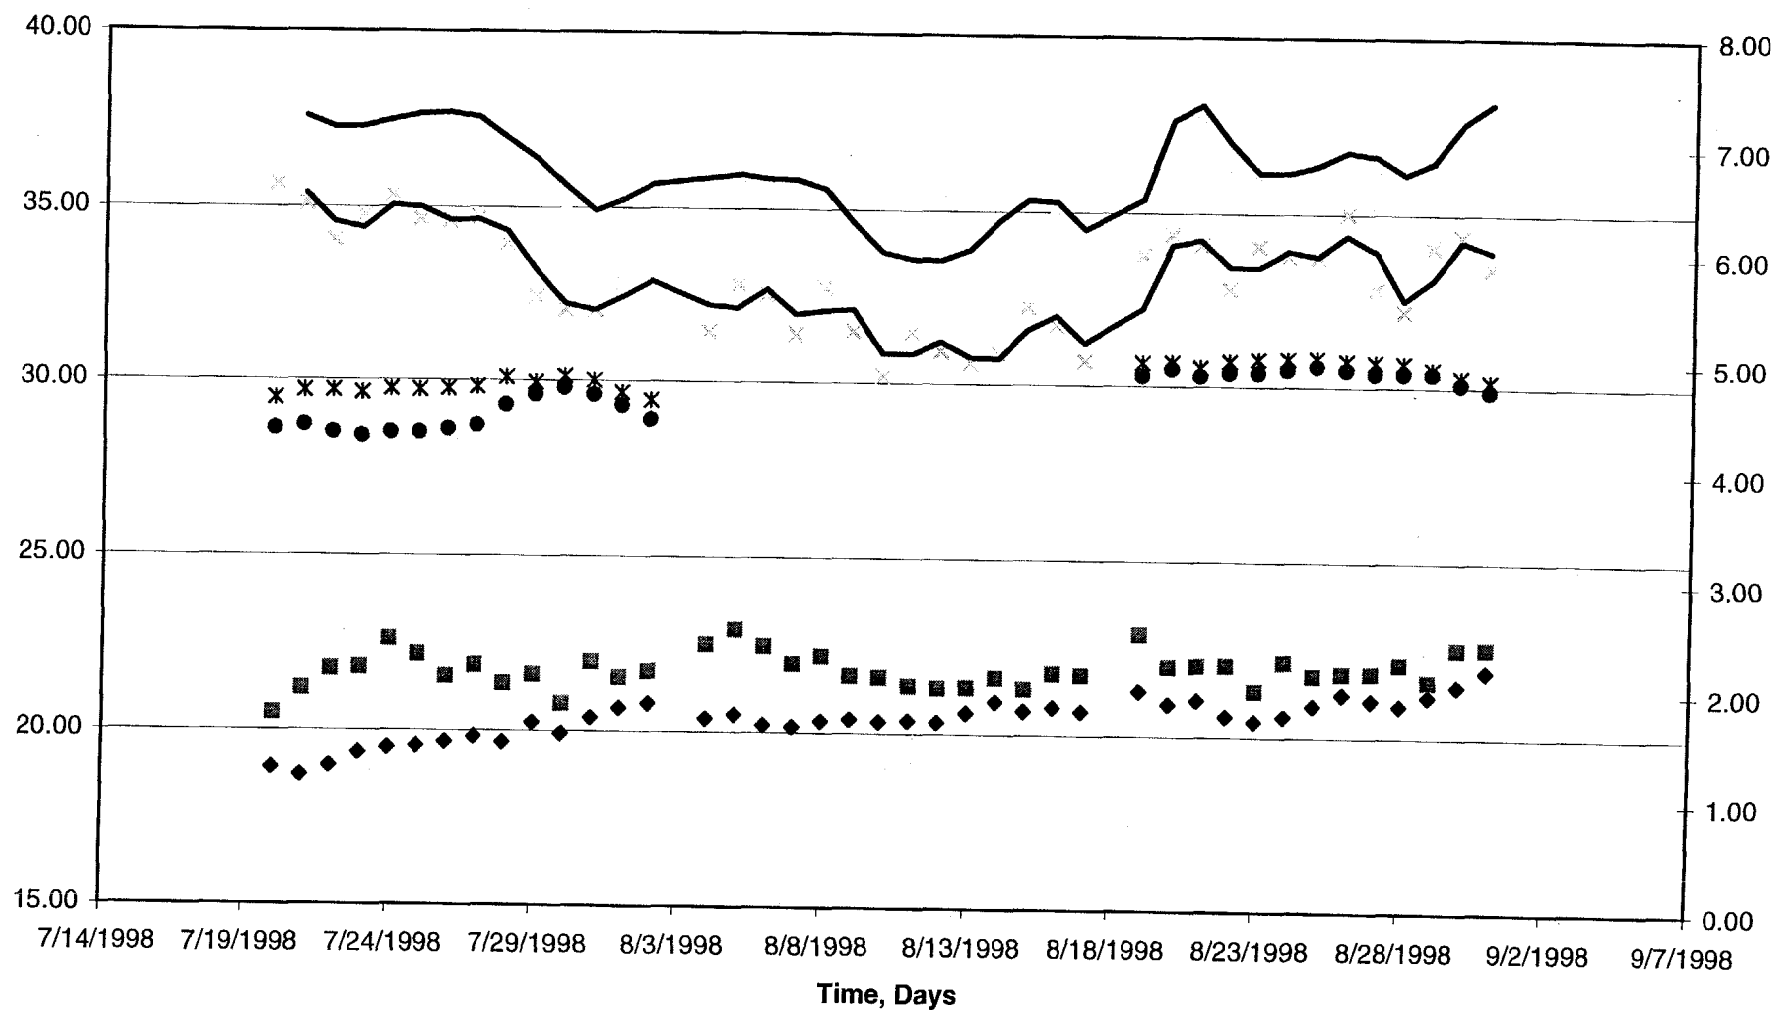
Figure 2. Time Series Water Quality Trends for DSY-40/41

Stillwater Basin data for temperature indicates similar trends for temperature and salinity as found for the reference area; as the deployment period progressed waters were warmer and more saline. It is also noted that there are no major salinity drops that might reflect freshwater input from storm drains or runoff.

As with the reference area, a general depression in DO occurred from about 8/10-8/16/98 the minimum values were above 5 mg/L. In contrast to the reference area, mean and minimum DO concentrations trended together and the absolute difference between mean and minimum concentrations was less than that observed for the reference area. Hence, the water quality data suggests that it is unlikely that these measured parameters would cause a reduction in water quality supporting benthic community colonization.

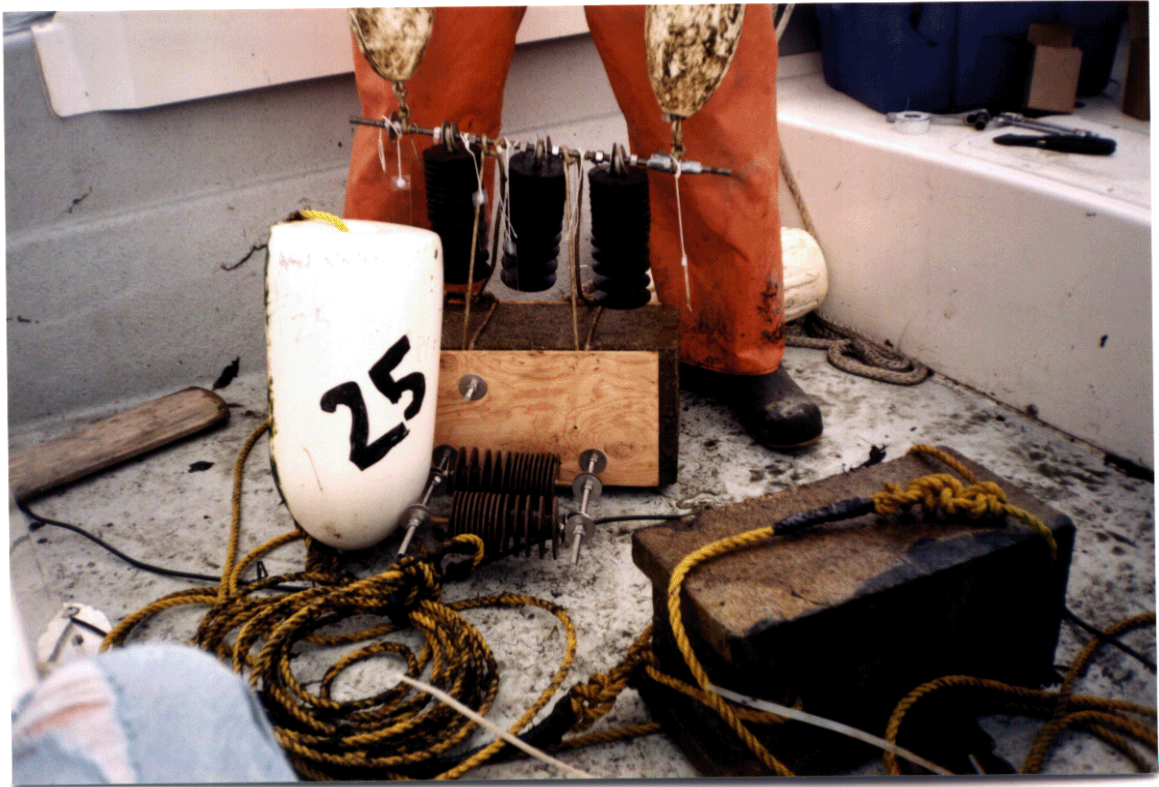
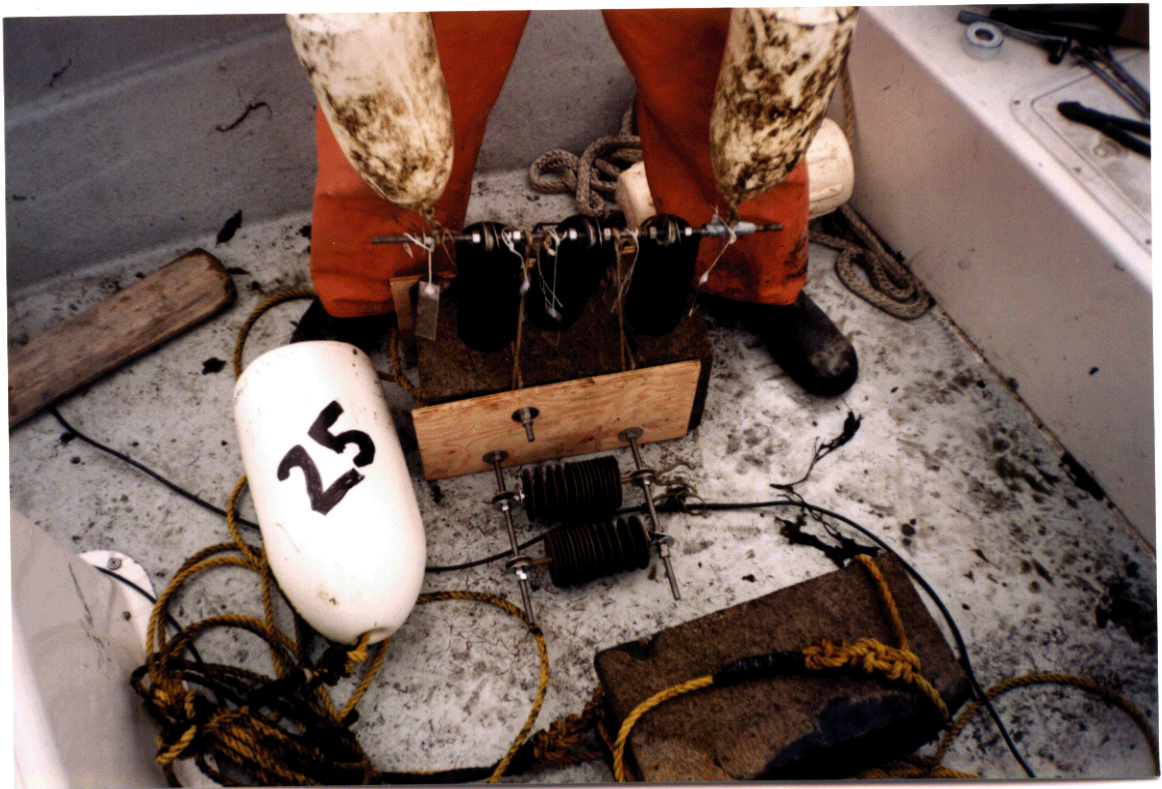
Photos of early summer Hester Dende deployment array, Station 25  
May 1998

The deployment was to be placed in early March and allowed to remain for a sixty day period. However, oversight parties were concerned that the arrays may not adequately measure the interference with growth that the sediment might provide because of the distance from the bottom. Therefore, at the end of the first deployment period (May 18, 1998) the arrays were reconfigured with new disks, and replaced at the stations described above. The new configuration allowed two strings of disks on each array to be placed in within 0.05 meters of the sediment surface. Three strings of disks were allowed to remain suspended in the water, approximately one foot from the bottom. Photos presented in Appendix C depict the reconfigured arrays.

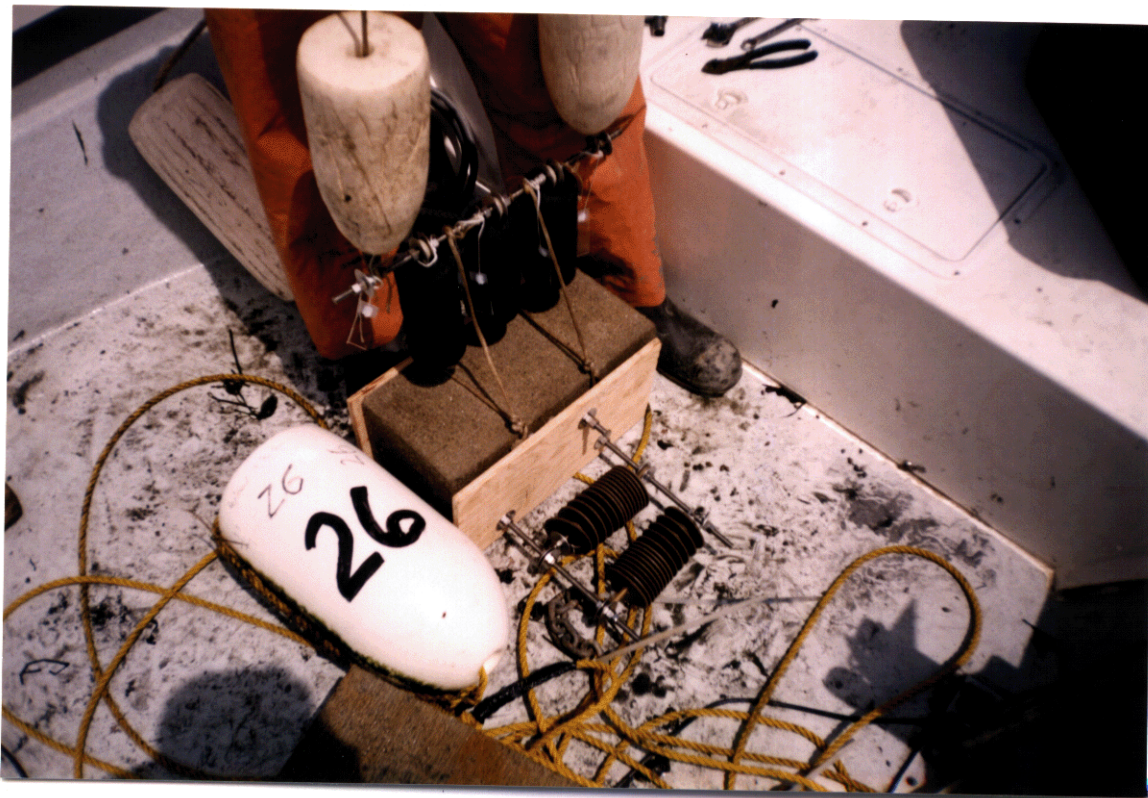
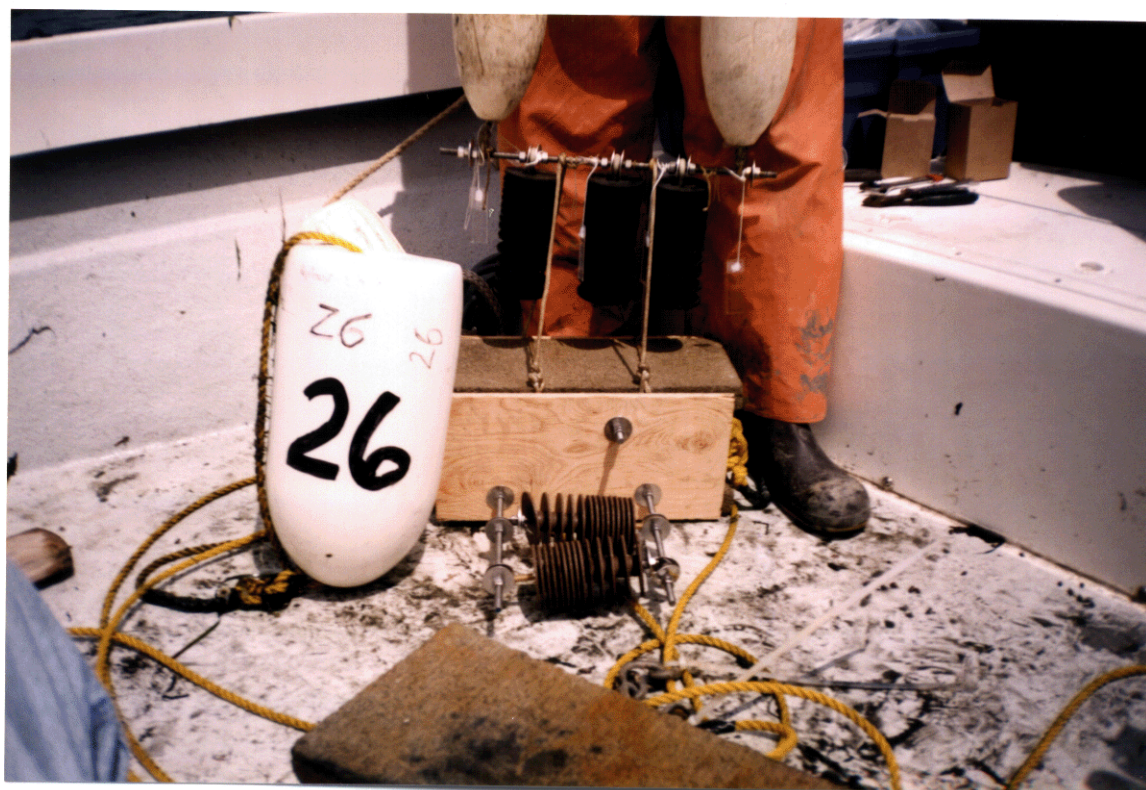
Photos of early summer Hester Dende deployment array, Station 26  
May 1998

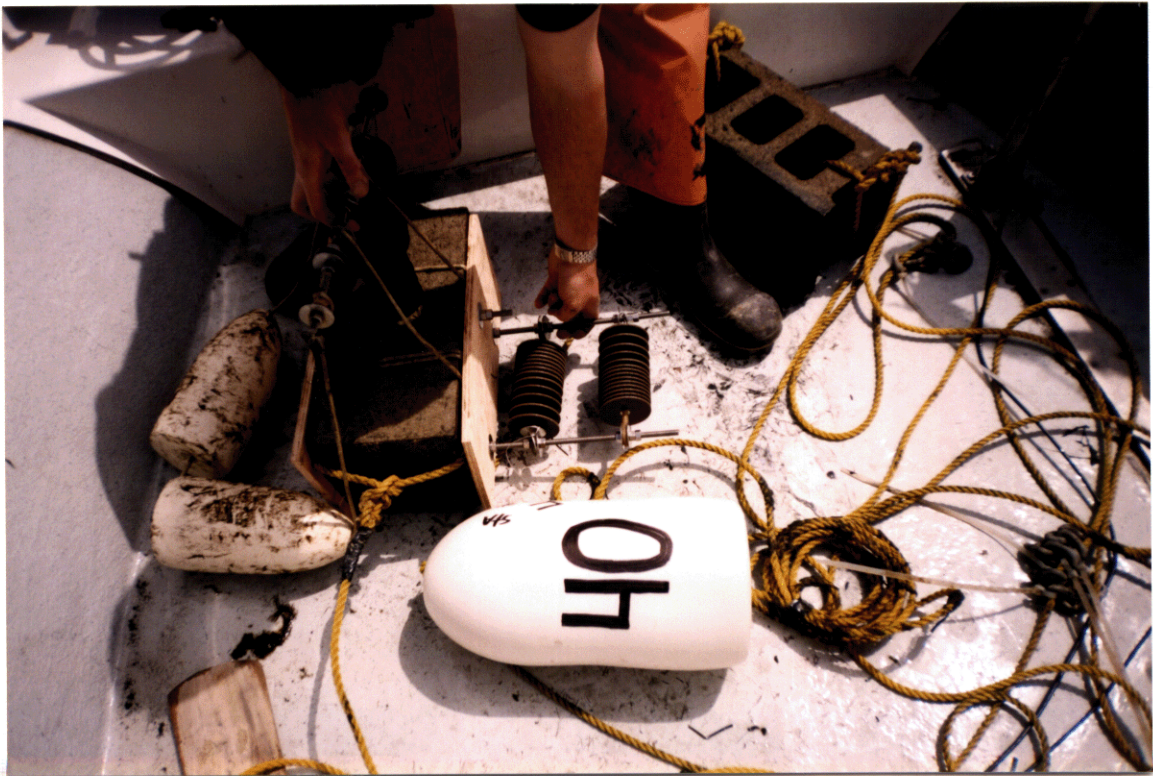
**Photos of early summer Hester Dende deployment array, Station 40  
May 1998**

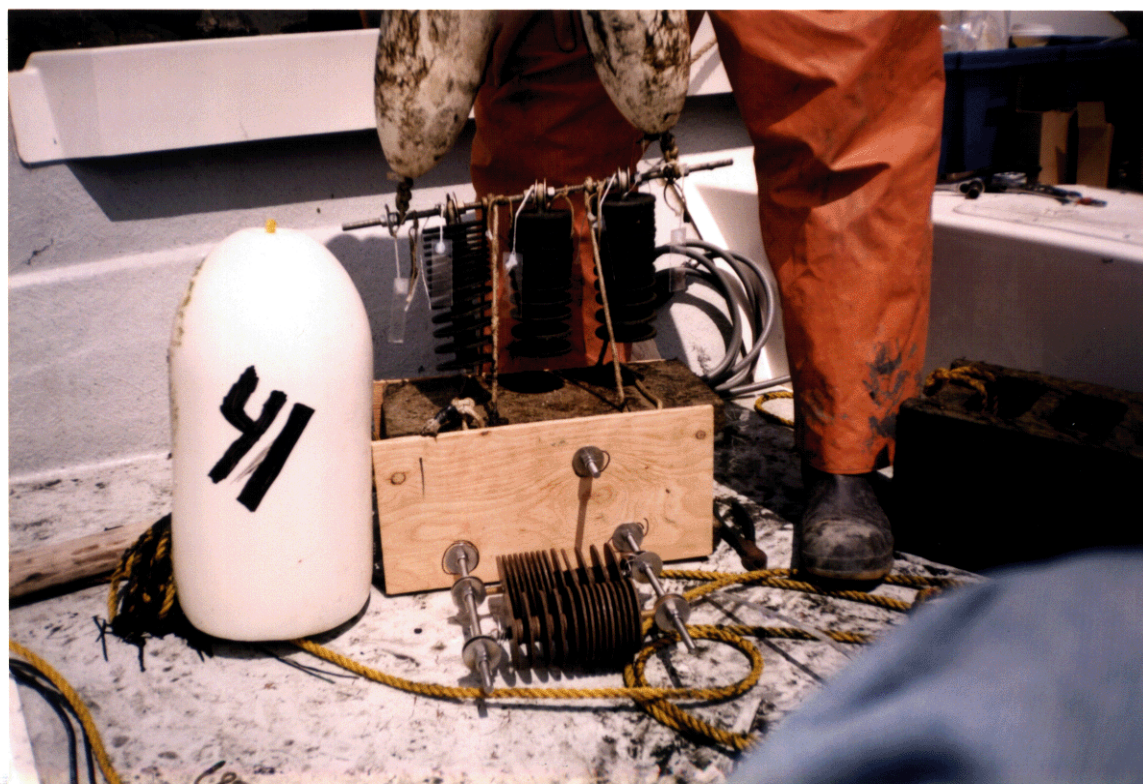
Photos of early summer Hester Dende deployment array, Station 41  
May 1998
